CONNECTICUT RIVER BASIN
BERLIN, CONNECTICUT

WASEL RESERVOIR DAM

CT. 00260

PHASE I INSPECTION REPORT
NATIONAL DAM INSPECTION PROGRAM

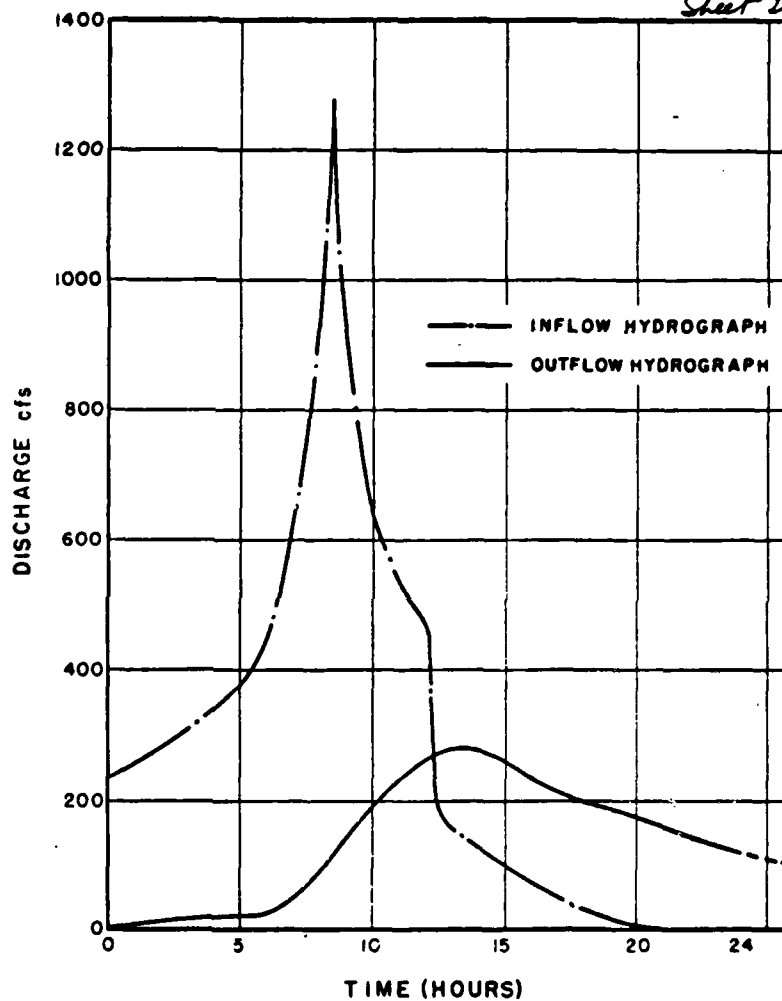
Sheet D-2

For the purpose of determining potential runoff from the 246 acre drainage area, the inflow flood hydrograph prepared by the design engineer is included in this report in Appendix D as Figure 2, Sheet D-2. The hydrograph is based on a 24-hour PMP of 28.5 in., peaking at about the 8th hour of the rainfall storm, at about 1,280 cfs. (see Sheets D-3 and 4, Appendix D). The total volume of the storm inflow would approximate 575 acre-ft.

According to that shown on Figure 2, Appendix D, the routing of the above PMP inflow flood through the reservoir and spillway results in a maximum spillway outflow of about 275 cfs. at reservoir surcharge head of 4.0 ft., to elevation 516.0. With top of dam at elevation 520, freeboards of 8 ft. over normal storage and 4.0 ft. over maximum surcharge storage would be realized. It is thus apparent that a threat of overtopping of the dam would not be possible.

2. An inflow hydrograph was constructed based on a 12-hour storm totalling 28 inches (maximum 12-hour storm as shown on U. S. Weather Bureau Report No. 23). This hydrograph is shown on Figure 2. It peaks in about 6.4 hours, with a maximum inflow,

including rainfall on the reservoir, of 1,280 cfs. The storm was routed through the reservoir using various spillway lengths and a length of 10 feet was selected as applicable. With this length, the outflow hydrograph shown on Figure 2 was obtained. The outflow hydrograph peaks about 14 hours after the start of the storm, with an outflow of 275 cfs and a reservoir elevation of 515.7, leaving 4.3 feet freeboard.

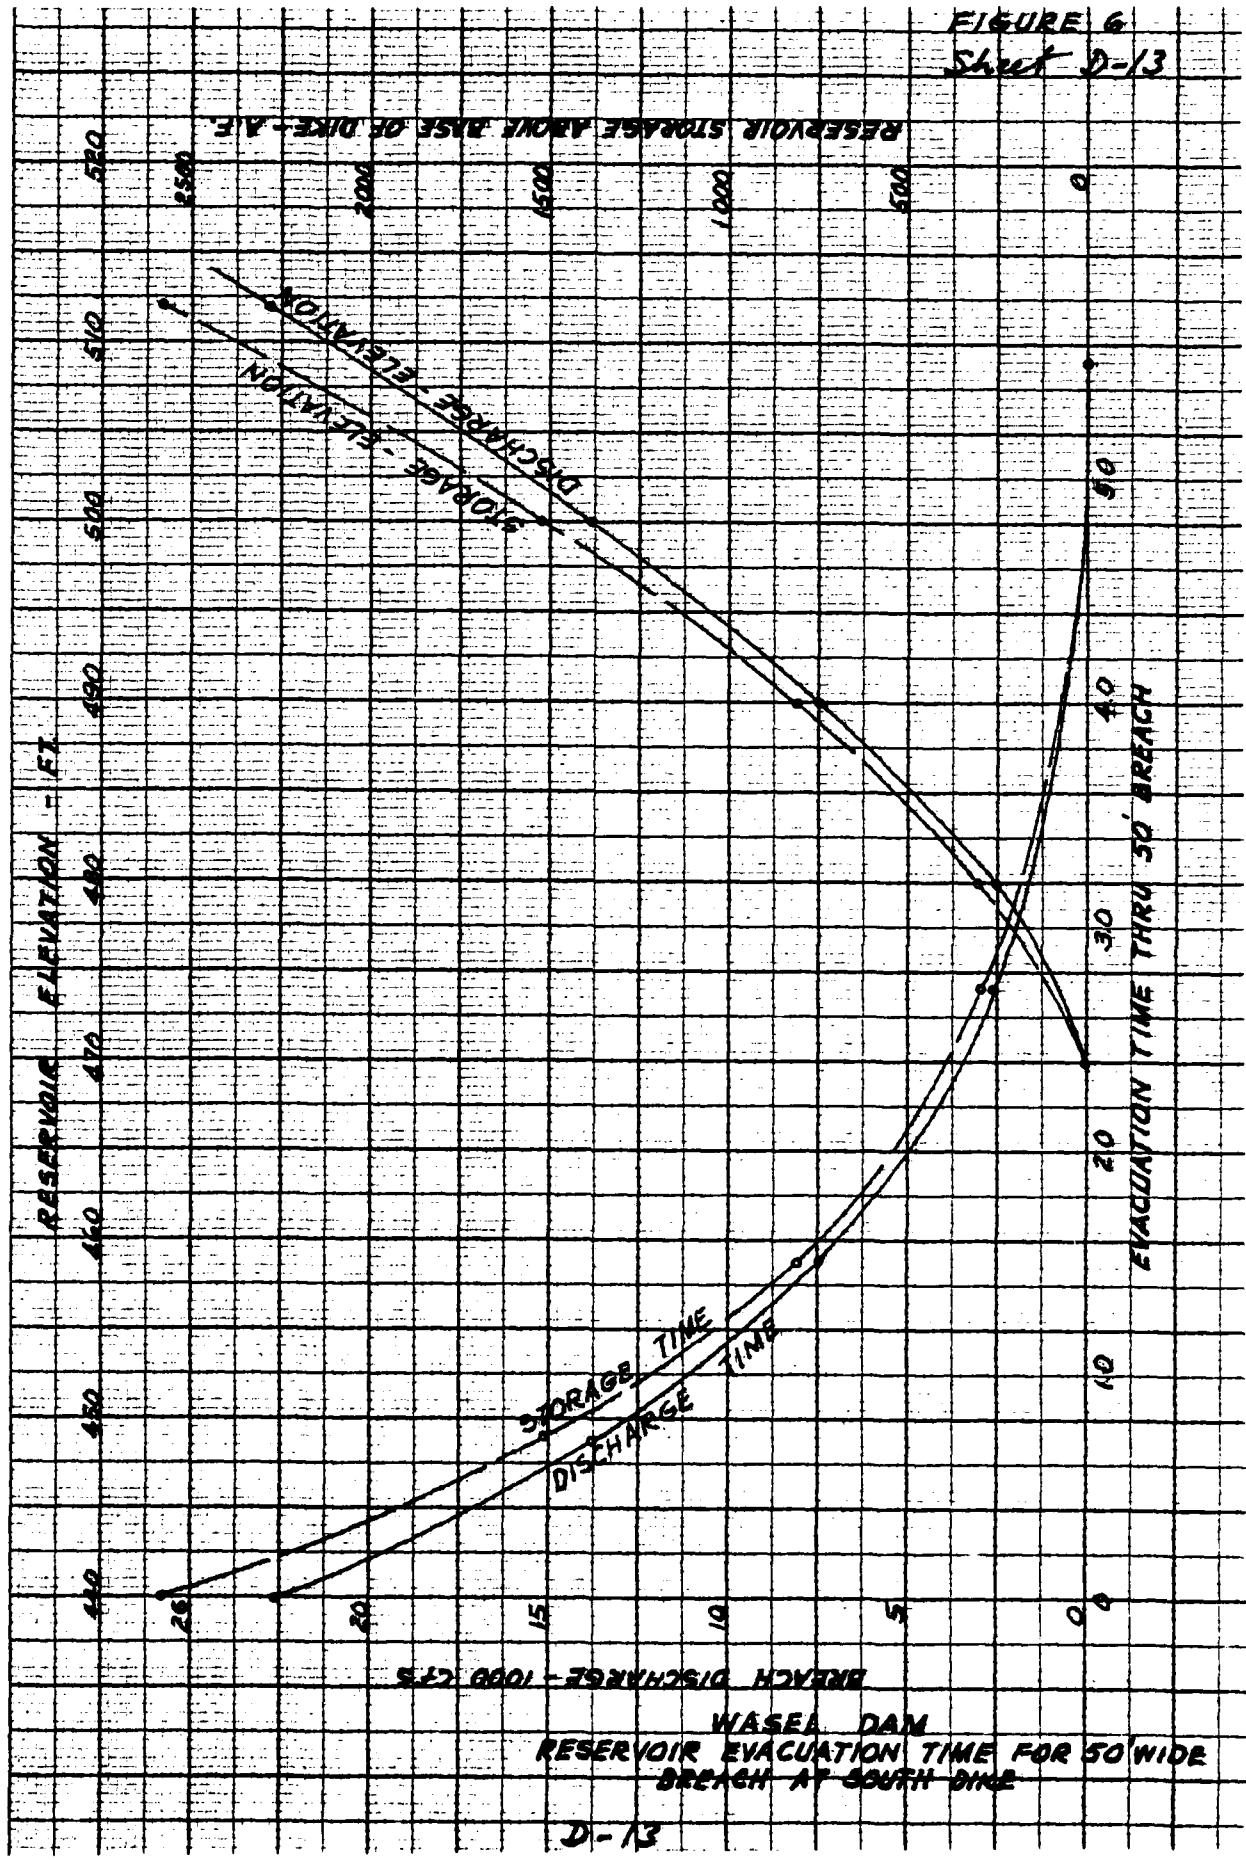
FIGURE 6
Sheet D-13

At the dike a 50 ft. breach failure would release up to 23,000 cfs. Plotted on Figure 6, Sheet D-13, are curves showing discharge and reservoir elevation versus emptying time for a 50 ft. breach at the dike.

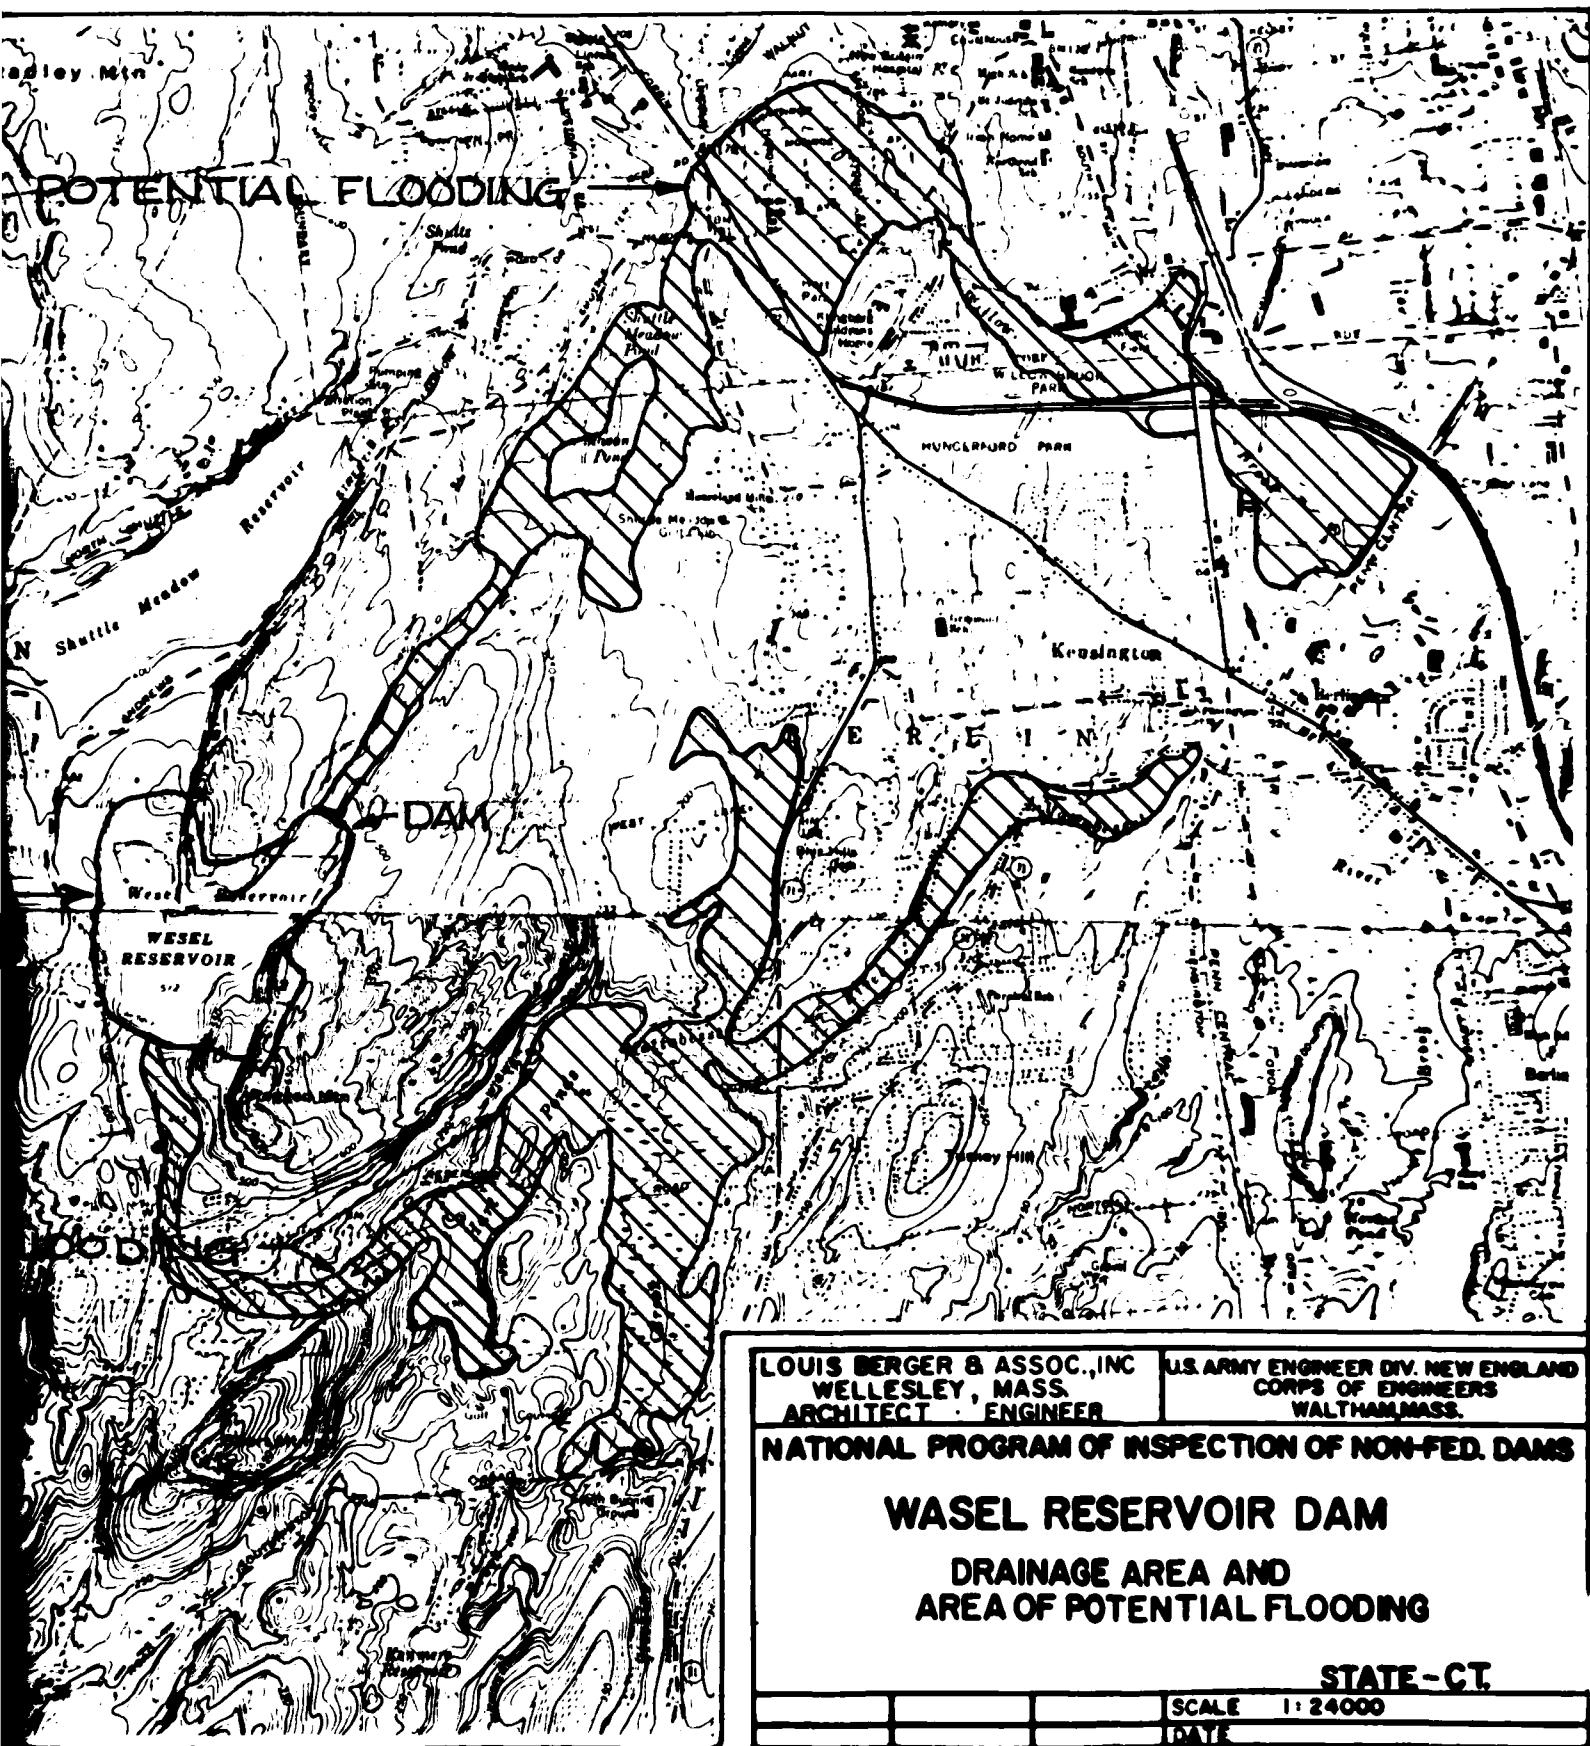
FIGURE 7 Sheet D-15

The areas which could be flooded by a breach failure of either the main dam or south dike are delineated on a map, Figure 7, Sheet D-15, in Appendix D. For a breach of the dam, pondage depths of about 30 ft. could accumulate in south New Britain. For a breach of the dike, homes east of Harts Pond would be affected.
